NASA Contractor Report 159293

**BEHAVIOR OF DAMAGED
GRAPHITE/EPOXY LAMINATES
UNDER COMPRESSION LOADING**

FINAL REPORT

BRUCE A. BYERS
BOEING COMMERCIAL AIRPLANE COMPANY
P.O. BOX 3707, SEATTLE, WA 98124

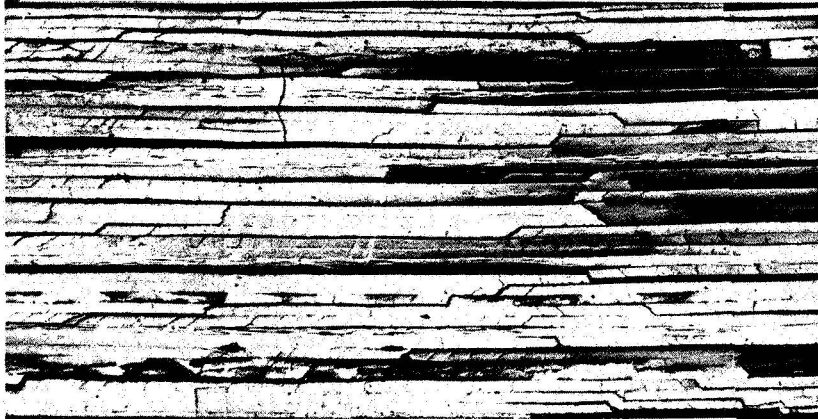
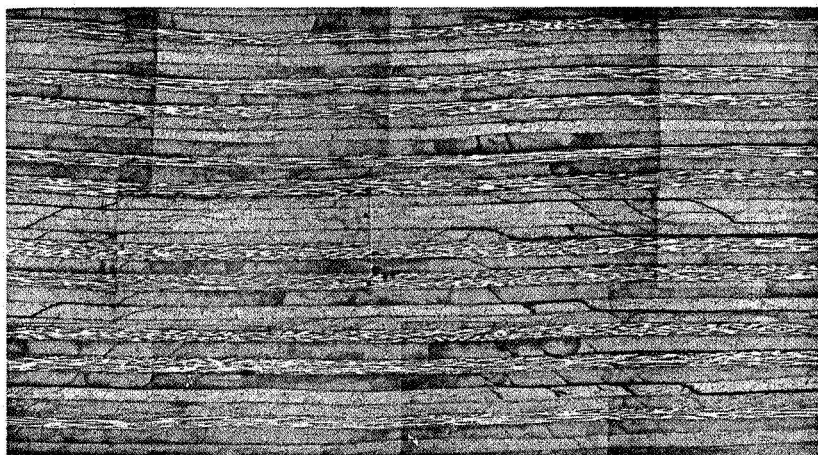
Figure 11. Comparison of Fracture Modes Following Low-Velocity Impact

- T300/5208
 - Impact = 15.8J (140 in-lb)
 - Delamination
 - Transverse cracks
 - Internally shattered

- T300/BP907
 - Impact = 31.6J (280 in-lb)
 - Delamination
 - Fiber fracture
 - Transverse cracks

- T300/P1700
 - Impact = 15.8J (140 in-lb)
 - No damage under impactor
 - Transverse cracks

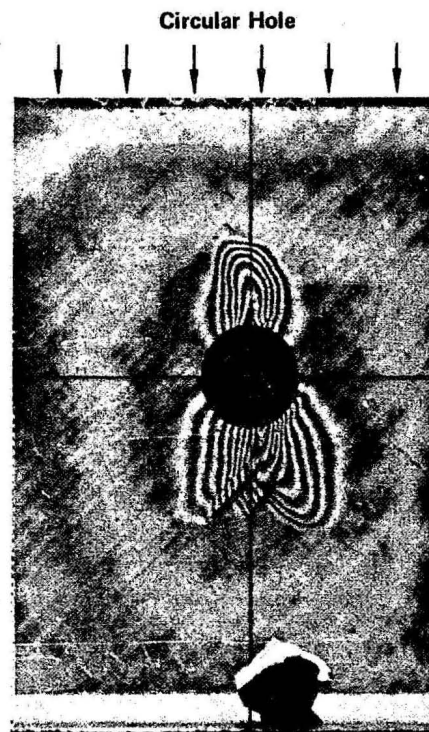
Figure 21. Extent of Surface Damage Prior to Compressive Failure—T300/5208

Strain = 10 900 $\mu\text{cm}/\text{cm}$

- Extensive delamination across specimen width
- Surface cracks

Strain = 6500 $\mu\text{cm}/\text{cm}$

- Some delamination
- Cracks

Strain = 3300 $\mu\text{cm}/\text{cm}$

- Slight delamination
- No visual cracks
